DATE: 28 October 2019
SUBJECT: Airway W37 Waypoint Issue
Impacted: A350 / A380 Customers Flying in Northern China
Cycles: 1912 – Effective Date 7 November 2019

SUMMARY

A change to one airway (W37) in AIRAC cycle 1911 has highlighted a software issue in A380/A350 FMS leading to repetitive resets during flight if the flight plan has a specific portion of the airway.

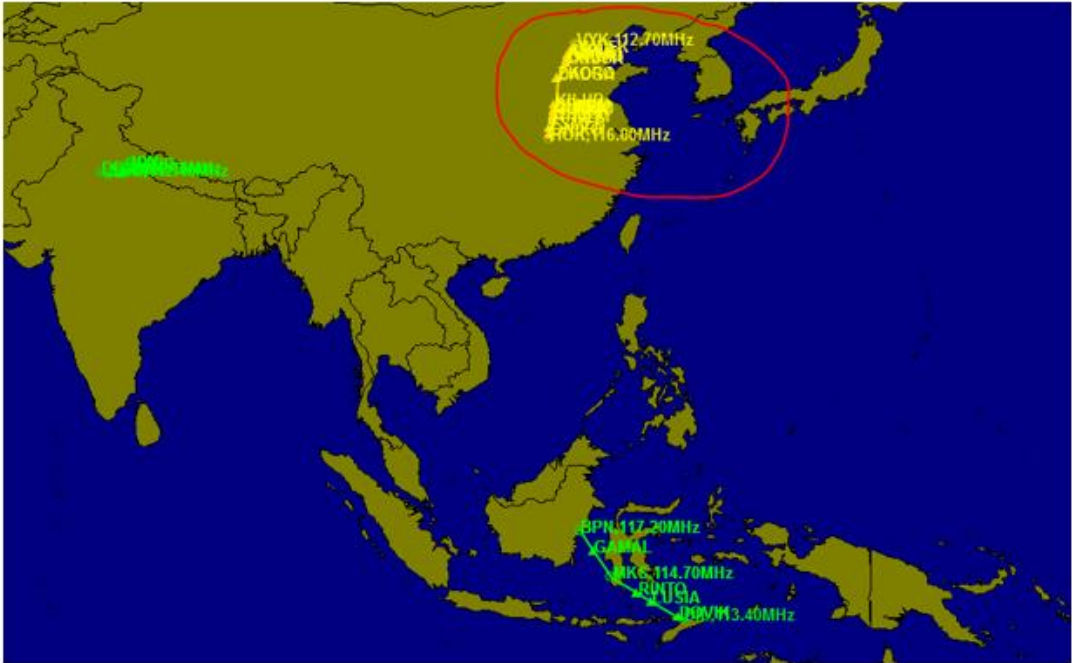
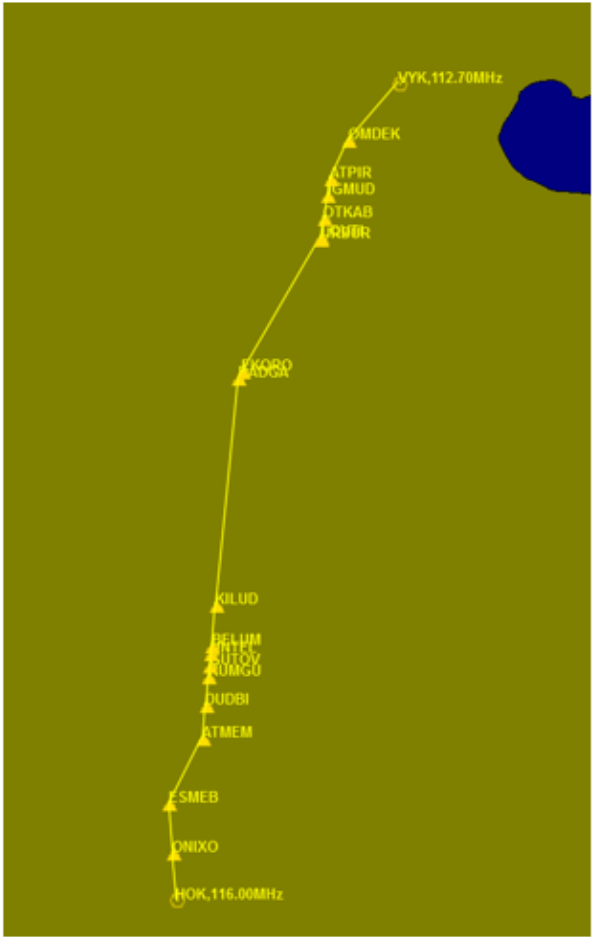
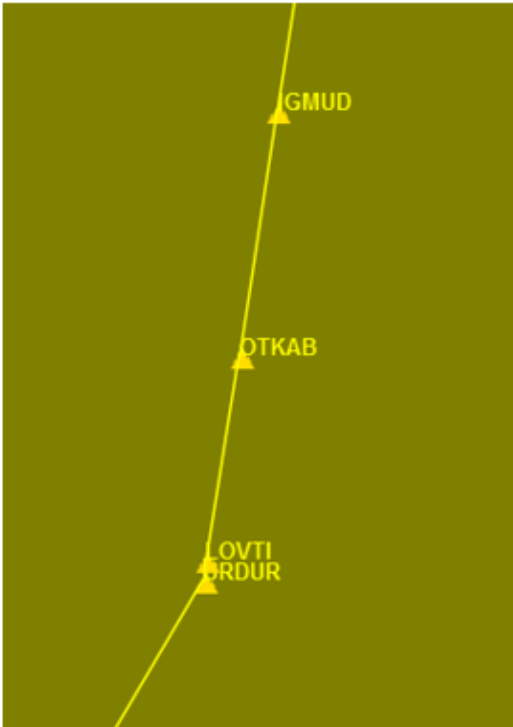
Honeywell received reports about repetitive FMS resets from A380 and A350 operators. Honeywell has identified the root cause of the issue which is triggered by a specific configuration of waypoints in Airway W37. The problem started to appear after several waypoints were added to Airway W37 that were very close in proximity to each other (distance from LOVTI to URDUR is 1.06 NM). Please see below.

Interim solution is required: **Honeywell will remove waypoint URDUR from Airway W37 starting in cycle 1912.**

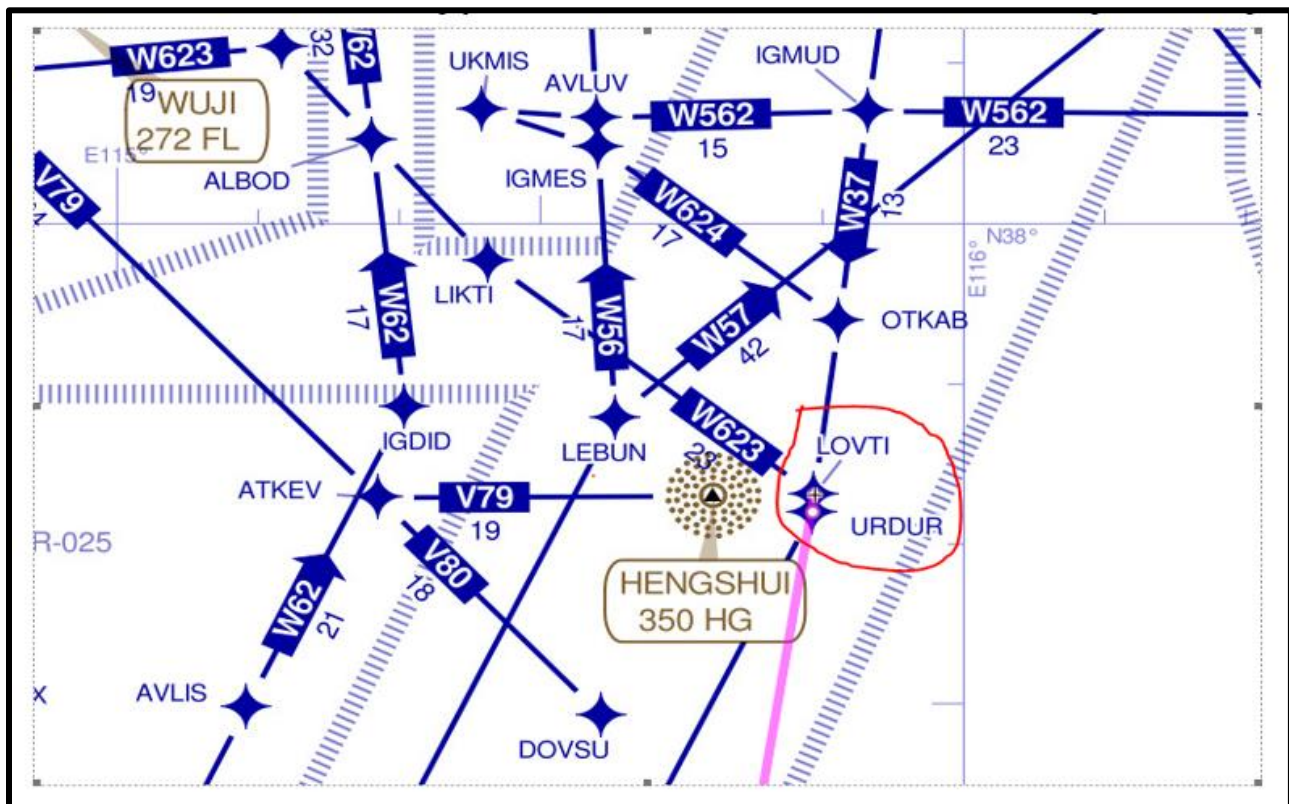
Waypoints Added in W37 for Cycle 1911

Addition of waypoints in
AIRAC cycle 1911 in W37

LOVTI = Intersection of Several Airways
